Manhole Inspection Summary

Manhole # S55M__009MH

Inspection ☐ Is Incomplete Rating: **5) Immediate Attention Required**

Location Address: **3600 odonnell st**

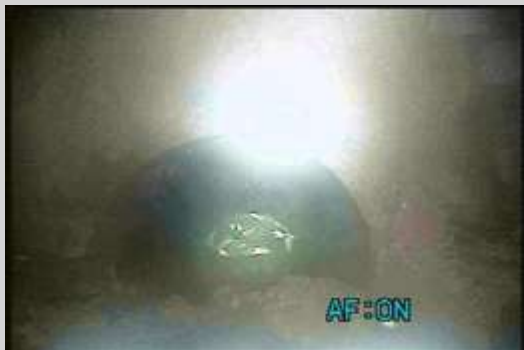
12 O'Clock Outflow

8 in. Circular Gravity Sewer
Pipe Out @ 12 O'Clock

Pipe Material: **Clay** ☐ Pipe Lined

Infiltration: **None** Pipe Seal Cond: **Unknown**
